### Via Alvarado Stream Survey

**Research Question:** What is the total discharge moving through Alvarado Creek at the survey cross section, and how does velocity and depth vary laterally across the channel?

### SDSU Aquaplex Canyon survey

### SDSU Northwest Campus Hillslope Degradation

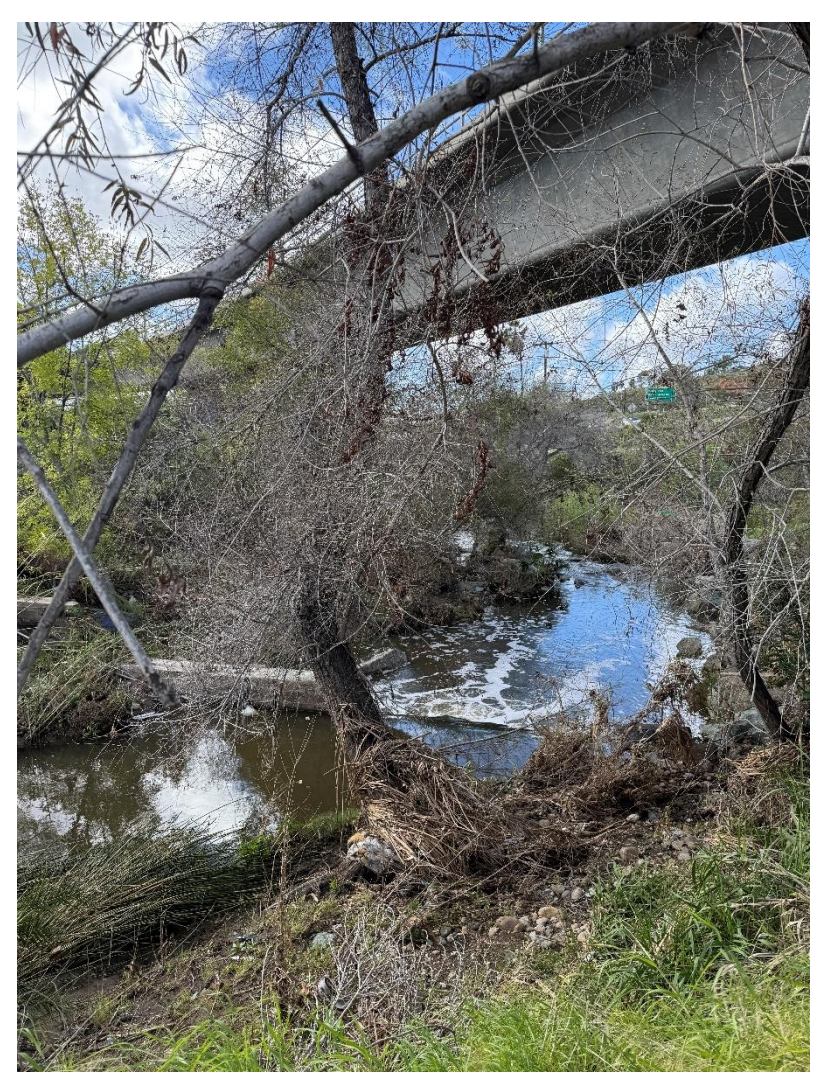
Image 2: Scour pool seen downstream of survey area.

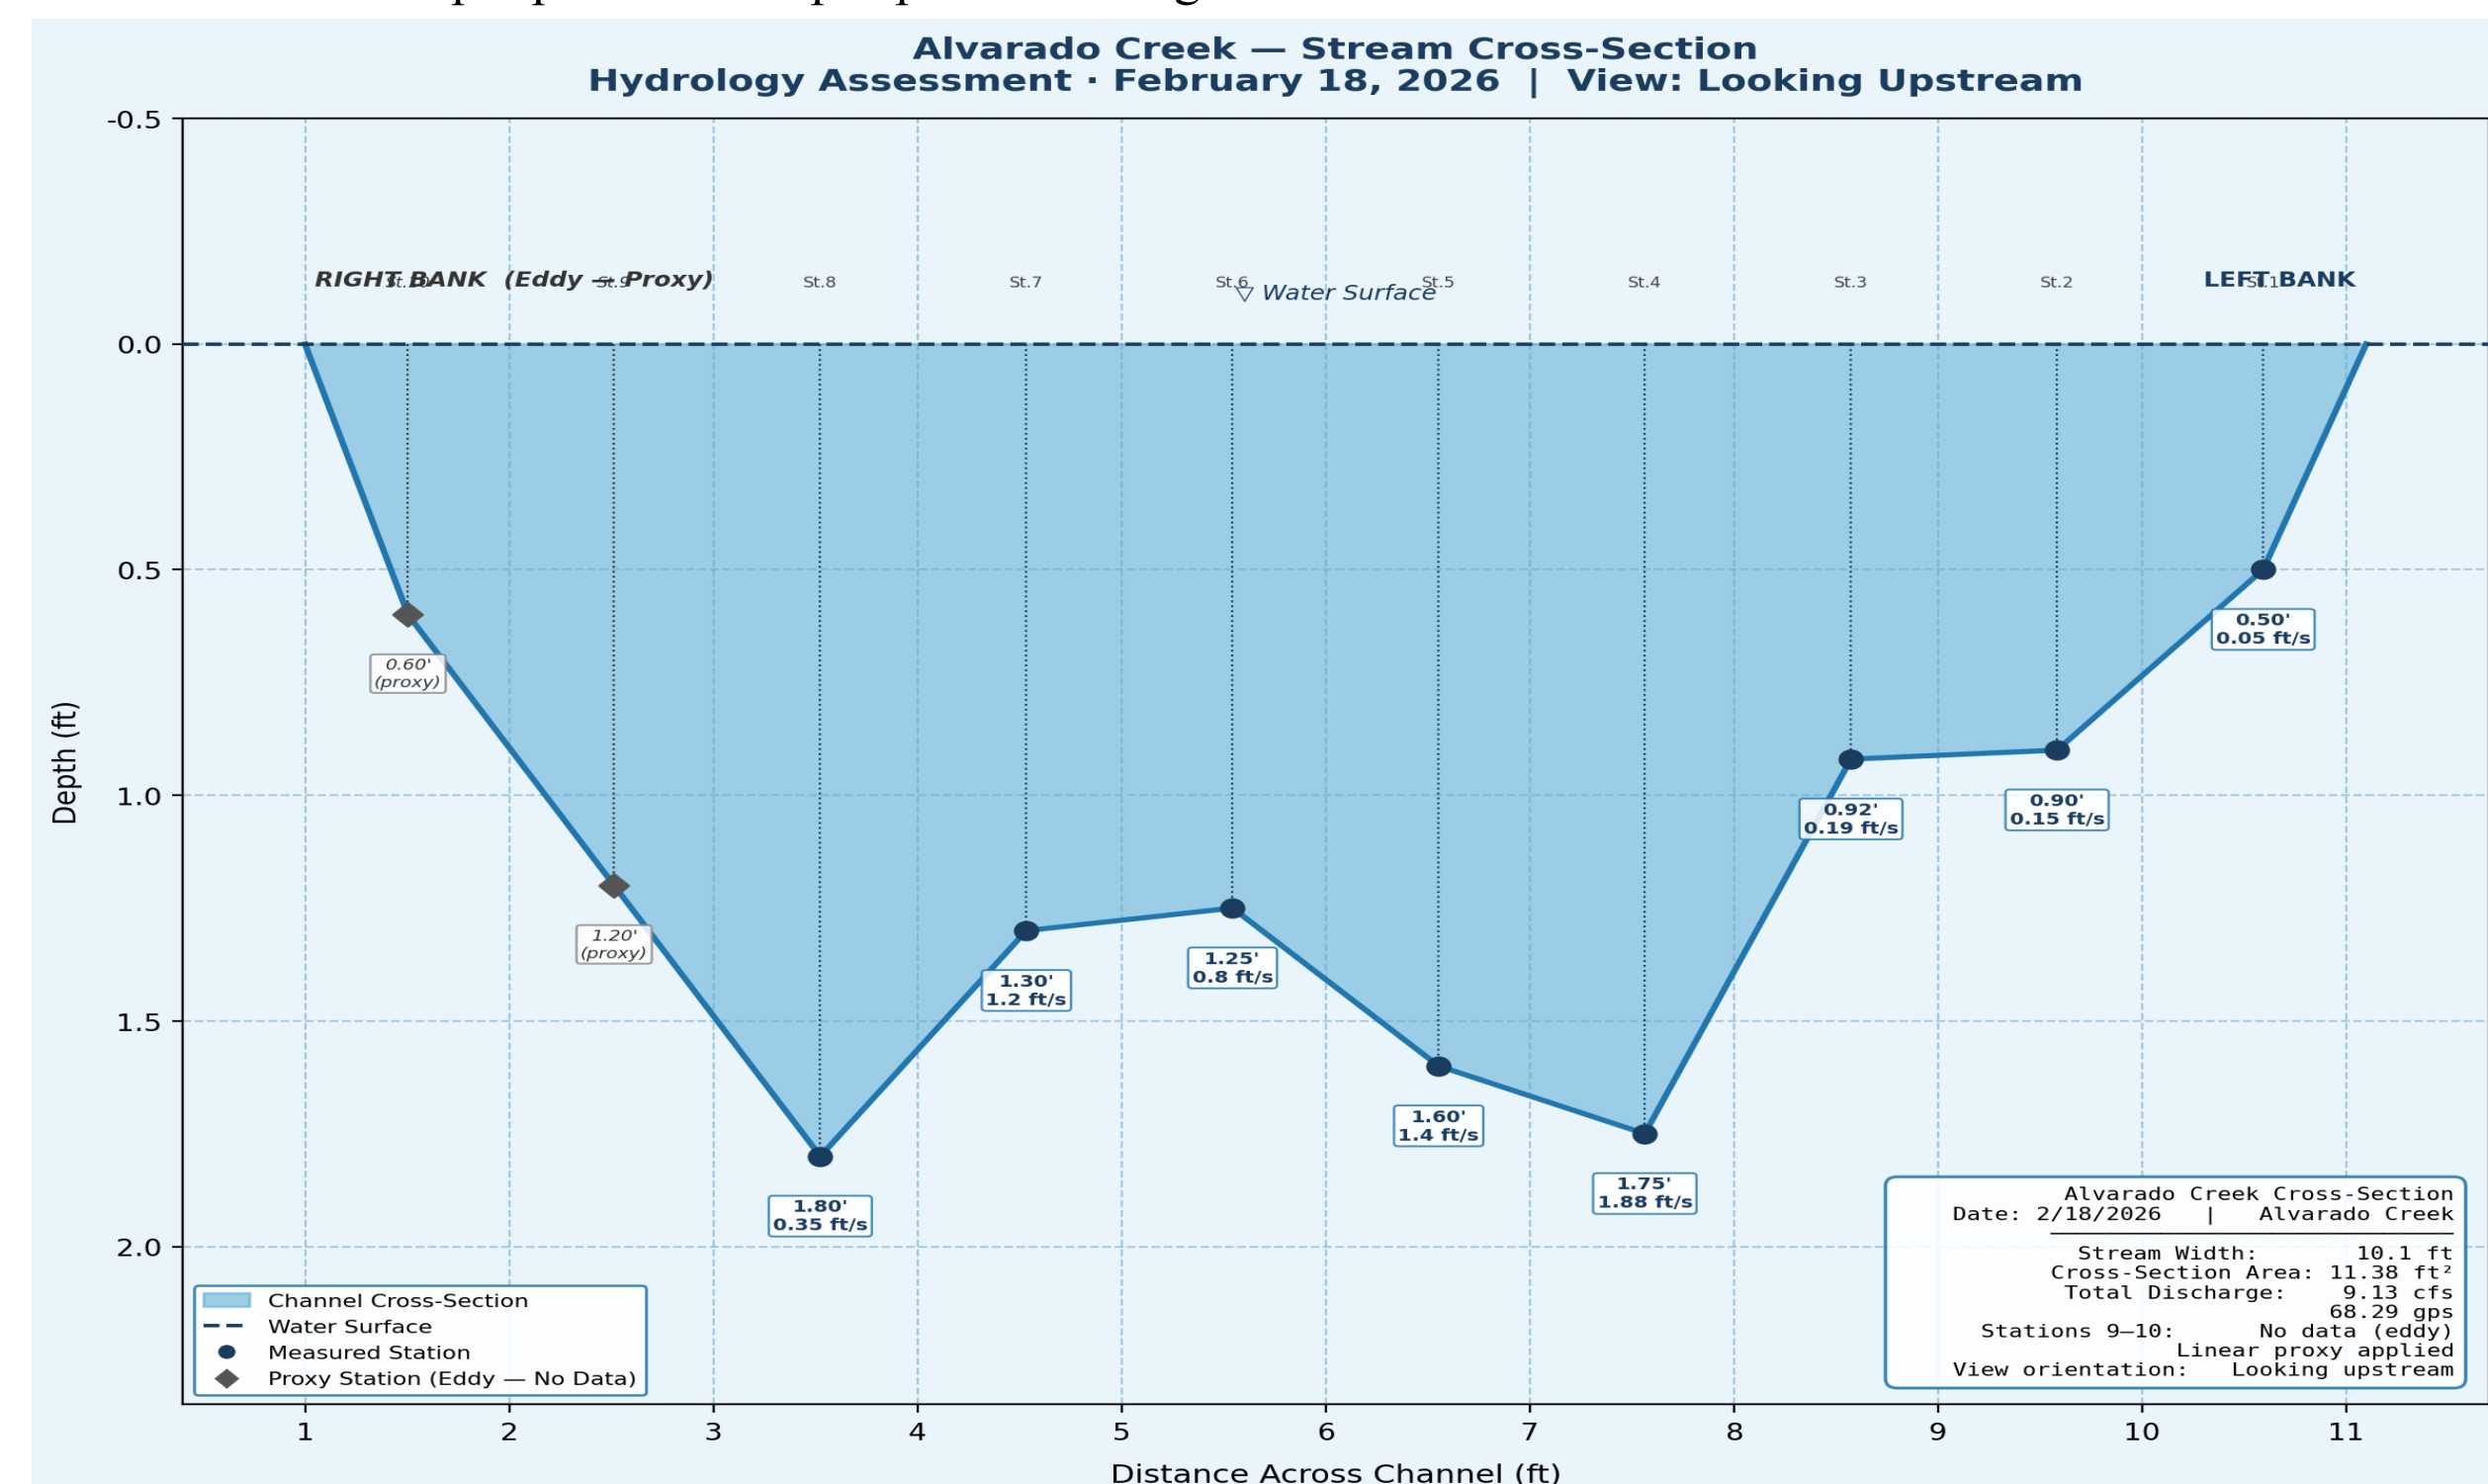
Figure 1: This figure shows the cross-section of the Alvarado creek and its total discharge rate.

- We divided the channel into 10 stations using a tape measure stretched across the cross section. At each station, we recorded water depth with a wading rod and measured point velocity at 60% depth using the Hach FH950, the standard single-point approximation of mean column velocity. Panel discharge was calculated as  $Q = V \times W \times D$  and summed across all panels to yield total cross-sectional discharge. Data was processed in Python and visualized as a depth profile and a per-panel discharge bar chart

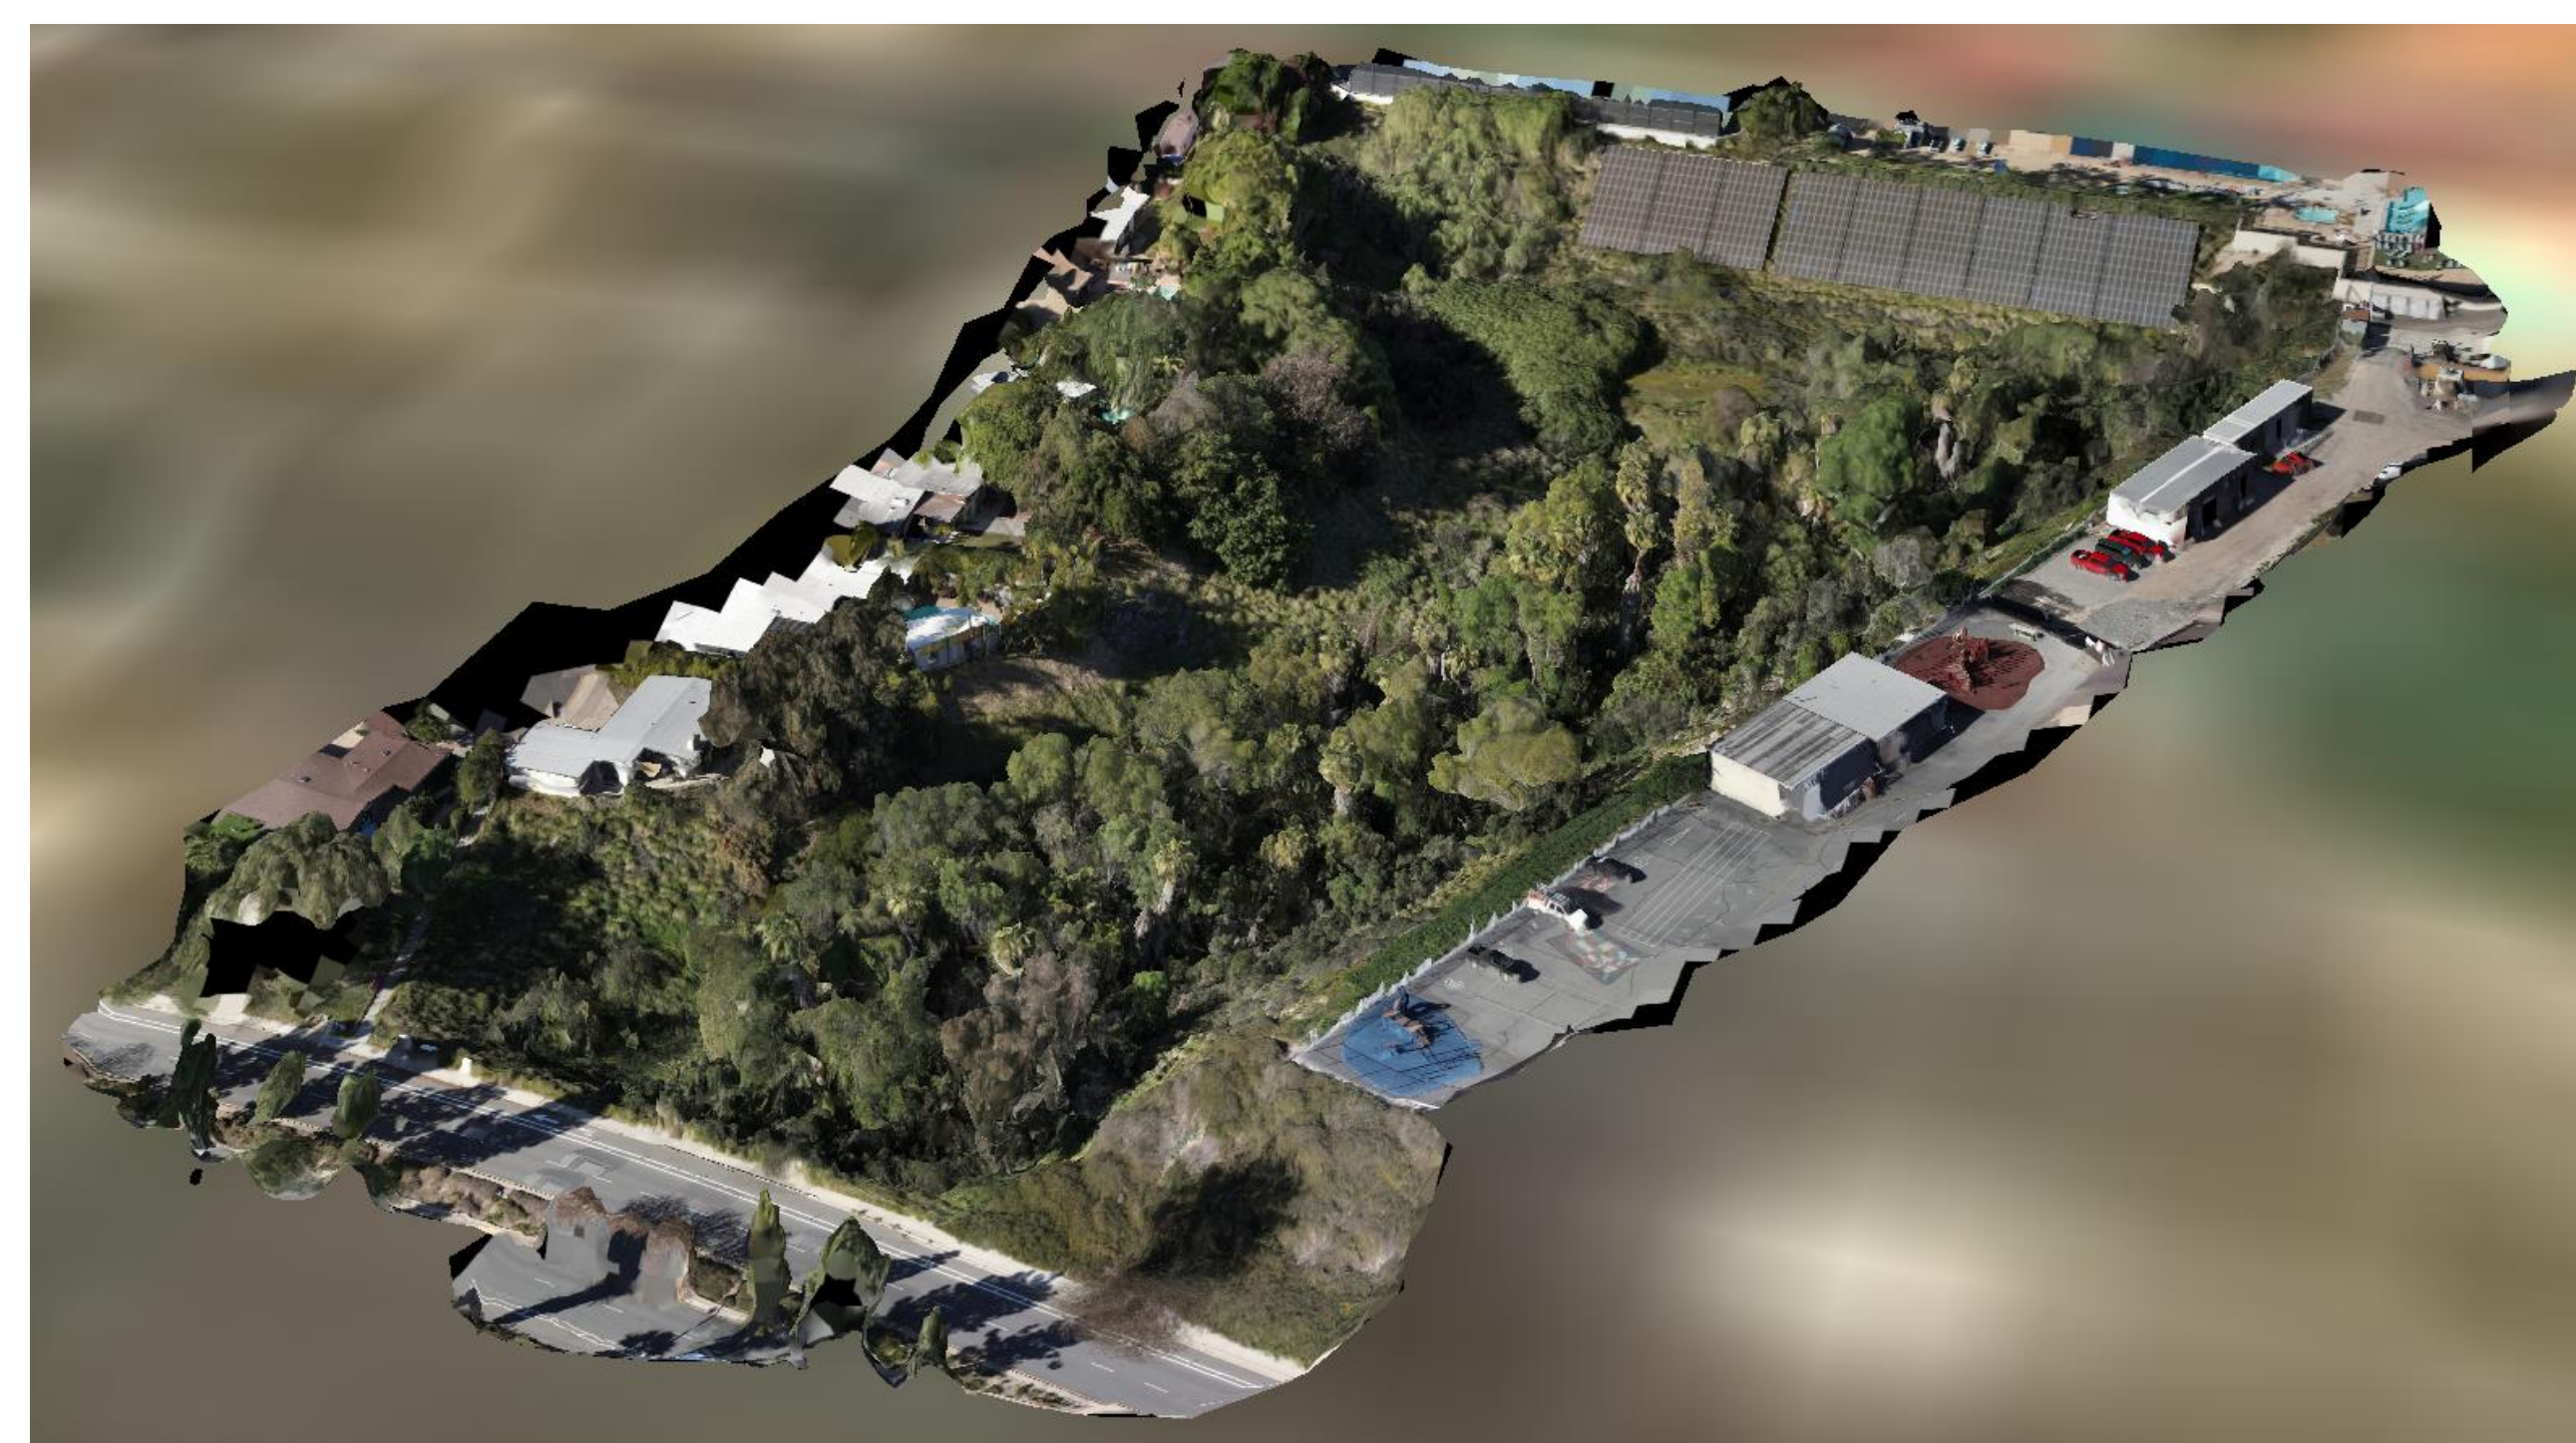
Image 5: SfM Photogrammetry of the canyon behind the Aquaplex. This was used to create the DEM model used to calculate valley erosional volume.

The April 3, 2026, survey used drone-based structure-from-motion (SfM) photogrammetry to document an active erosional scarp on the hillslope above the SDSU Aquaplex (Image 5). Overlapping aerial imagery was processed in Agisoft Metashape to generate a point cloud, digital elevation model (DEM), and orthophoto of the feature (Figure 2). SfM photogrammetry has become a widely adopted low-cost alternative to traditional ground-based survey for characterizing small-scale geomorphic features at high resolution. Key findings from the survey include:

- The scarp exhibited clear signs of active erosion: exposed soil horizons, tension cracking at the headwall, and a debris lobe accumulating at the toe.
- DEM analysis revealed a scarp face approximately 2–3 meters in height, with slope gradients across the degraded area measurably steeper than the surrounding stable hillslope (Figure 2).
- Erosion is likely accelerated by discharge from a broken drainage pipe originating in the parking lot immediately east of the canyon, which delivers concentrated surface flow directly onto the scarp face; sparse vegetative cover at the headwall further reduces surface cohesion and root reinforcement, leaving the slope largely unprotected against continued incision.

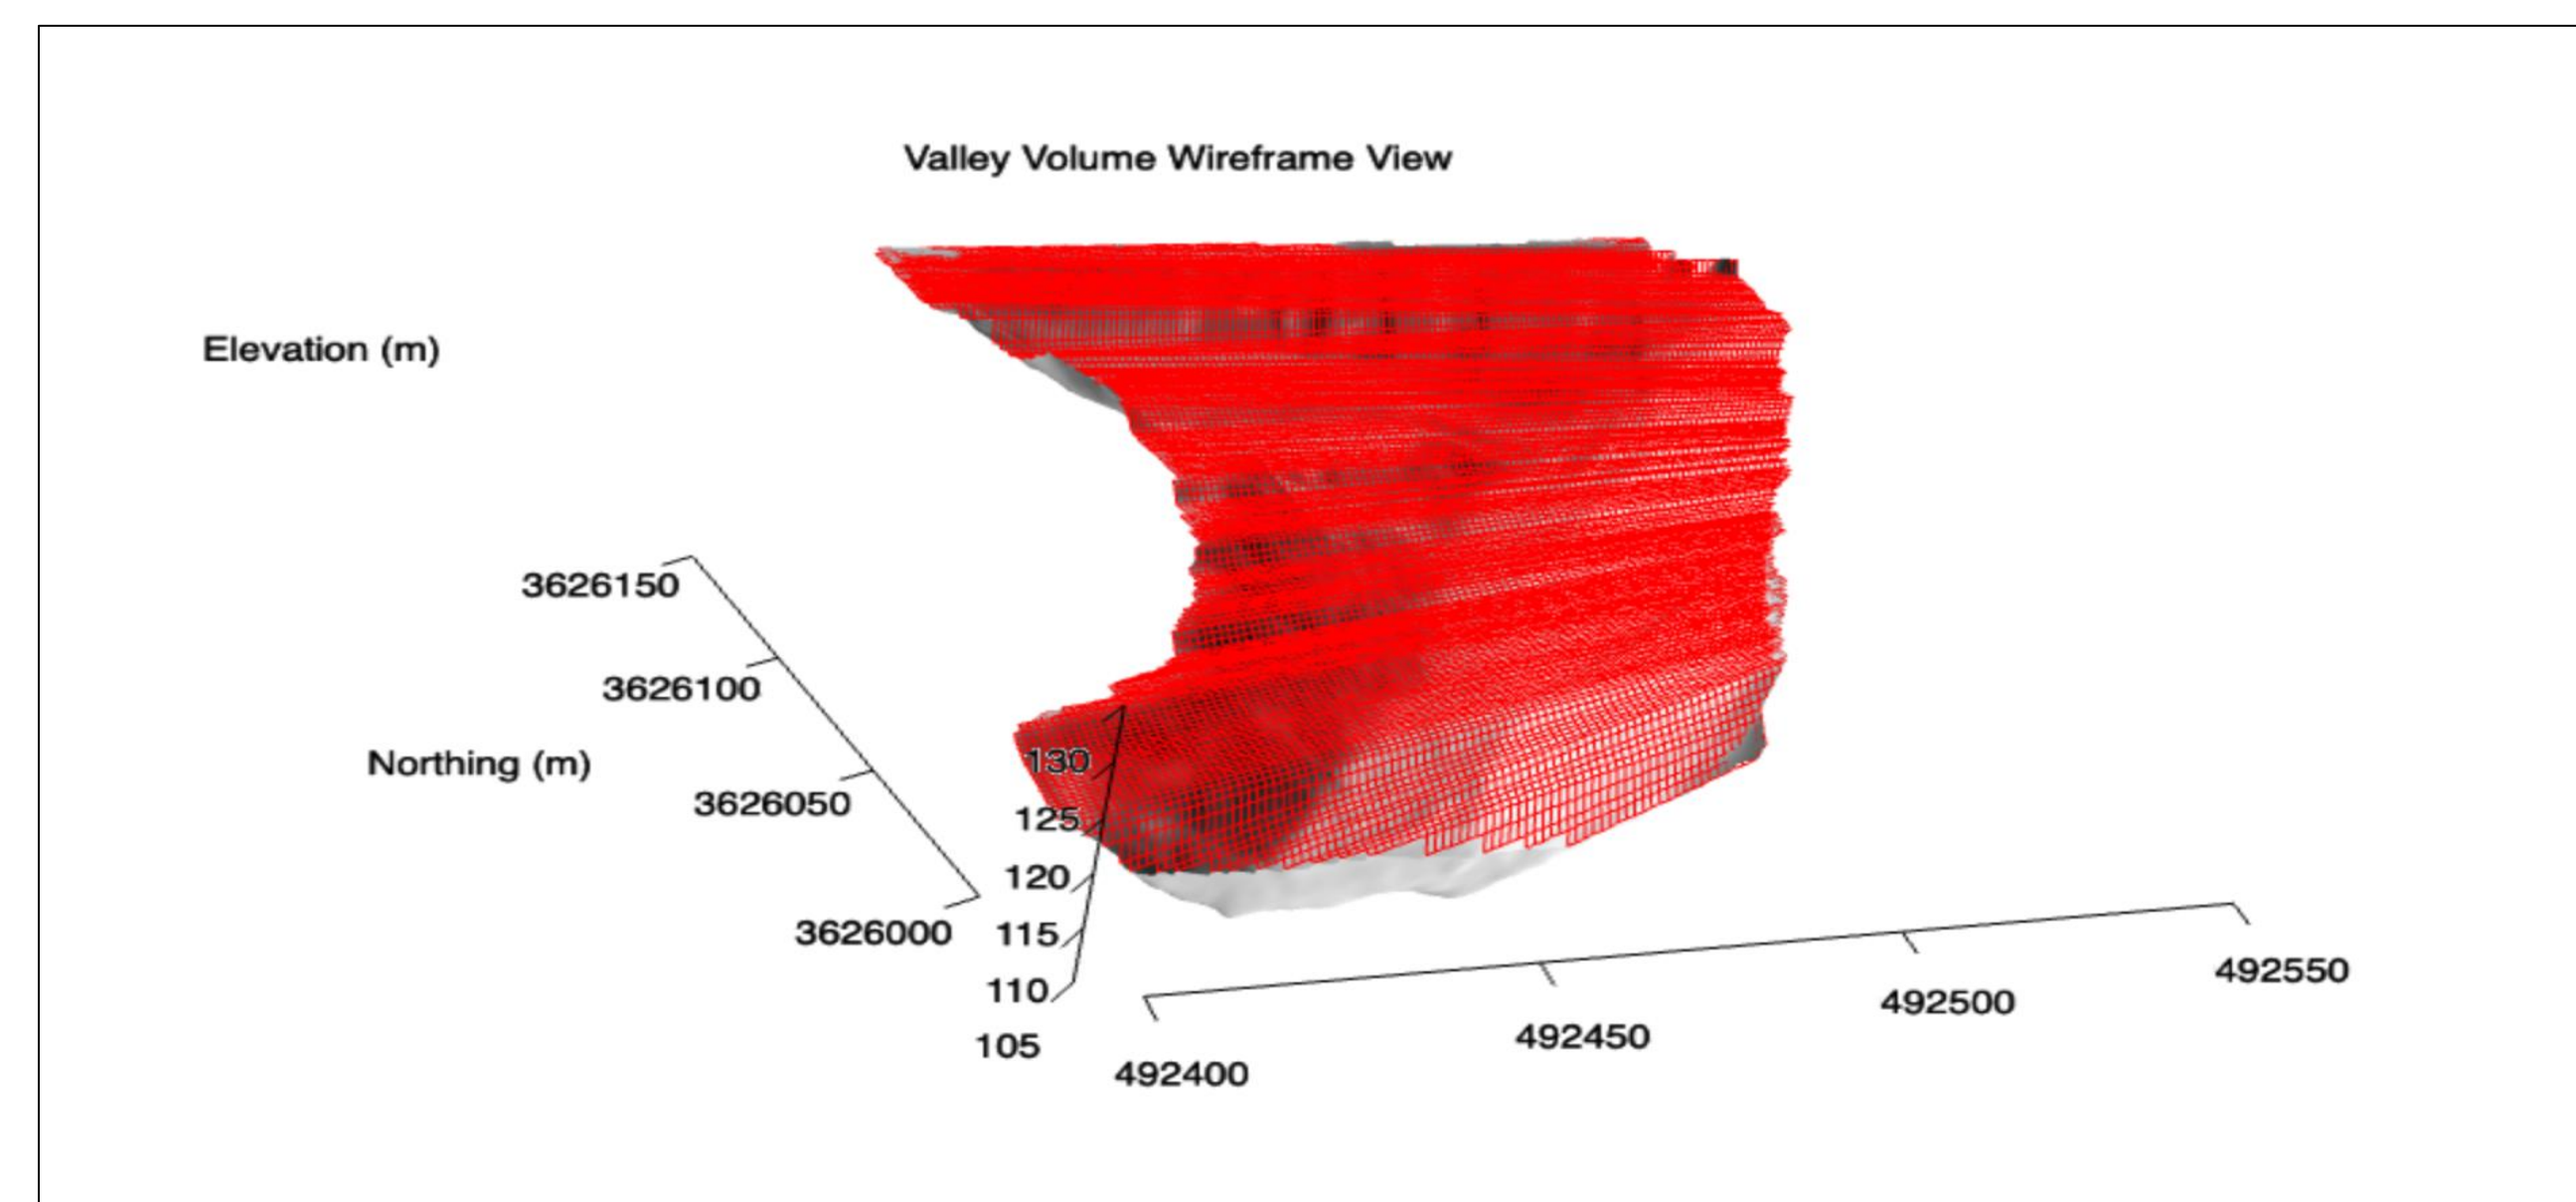
Figure 2: The above figure shows the 3D model created in RStudio to determine erosional volume of canyon.

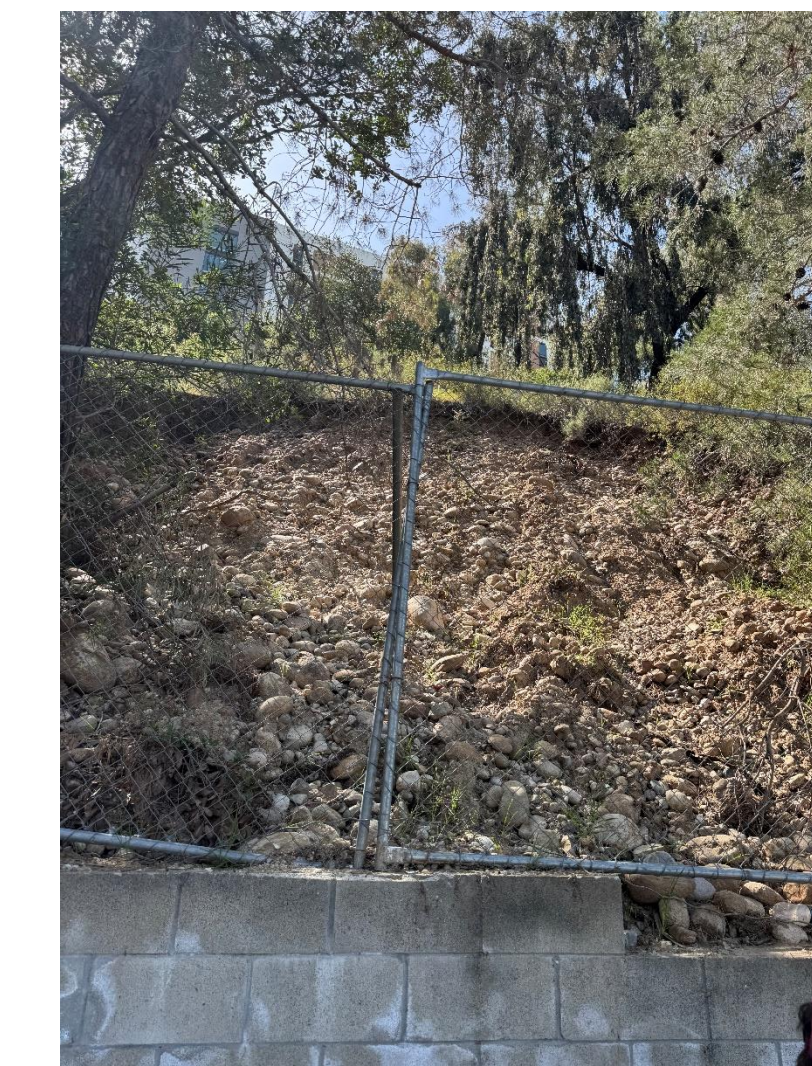
Image 6: Construction fence on east side of campus housing, holding back rocks from mass wasting slide event.

- Urban development has both increased slope instability through grading, vegetation removal, and impervious surface runoff, and necessitated active mitigation through engineered construction fences (Image 6), retaining walls (Image 7), and subsurface drainage systems designed to intercept and redirect slope flow.

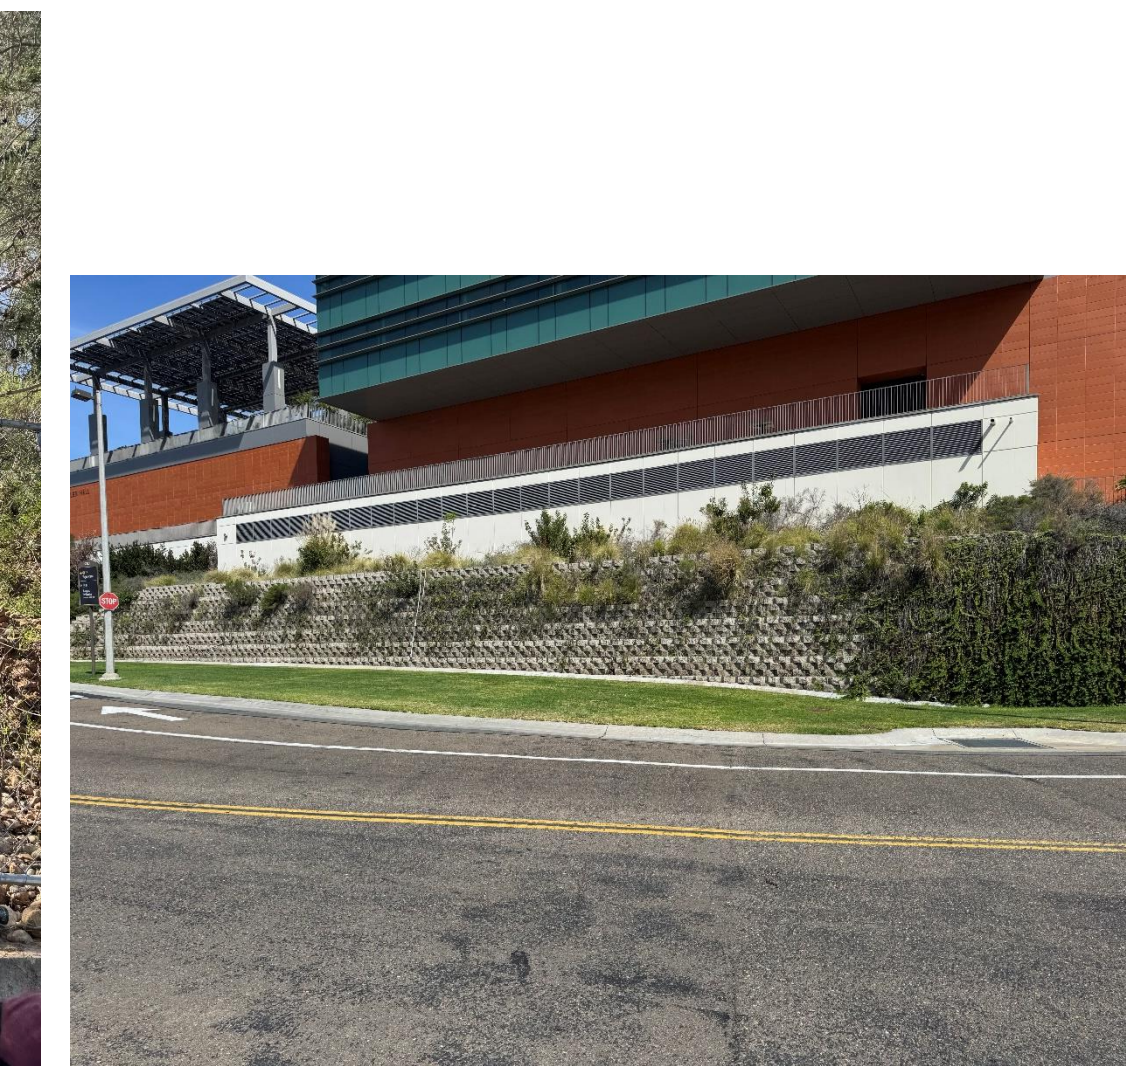
Image 7: Retaining wall below west side of Storm Hall.

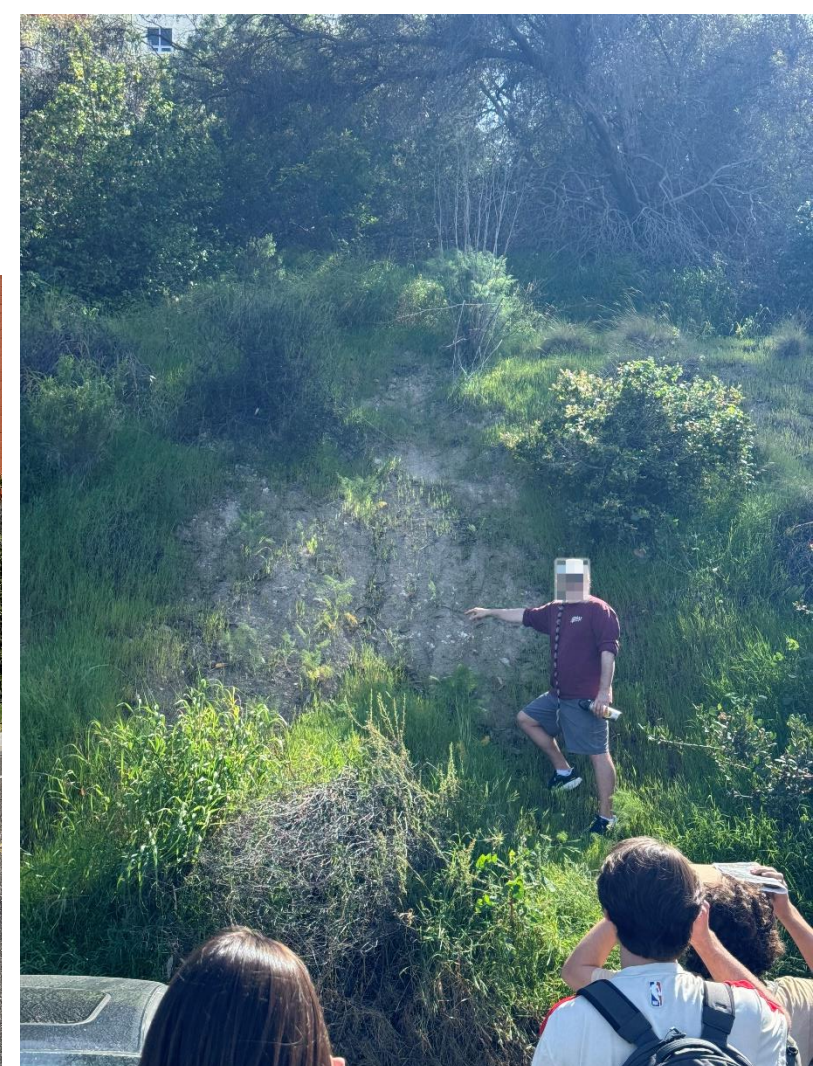
Image 8: Professor J. Bissell pointing out that loss of vegetation will accelerate erosional events.

- Eight to nine discrete mass wasting scars were identified on the parking lot hillslope alone (Images 8 and 9), indicating repeated and ongoing failure events at this location; slopes in this area approached 65° in places, well exceeding the typical angle of repose for unconsolidated granular material.

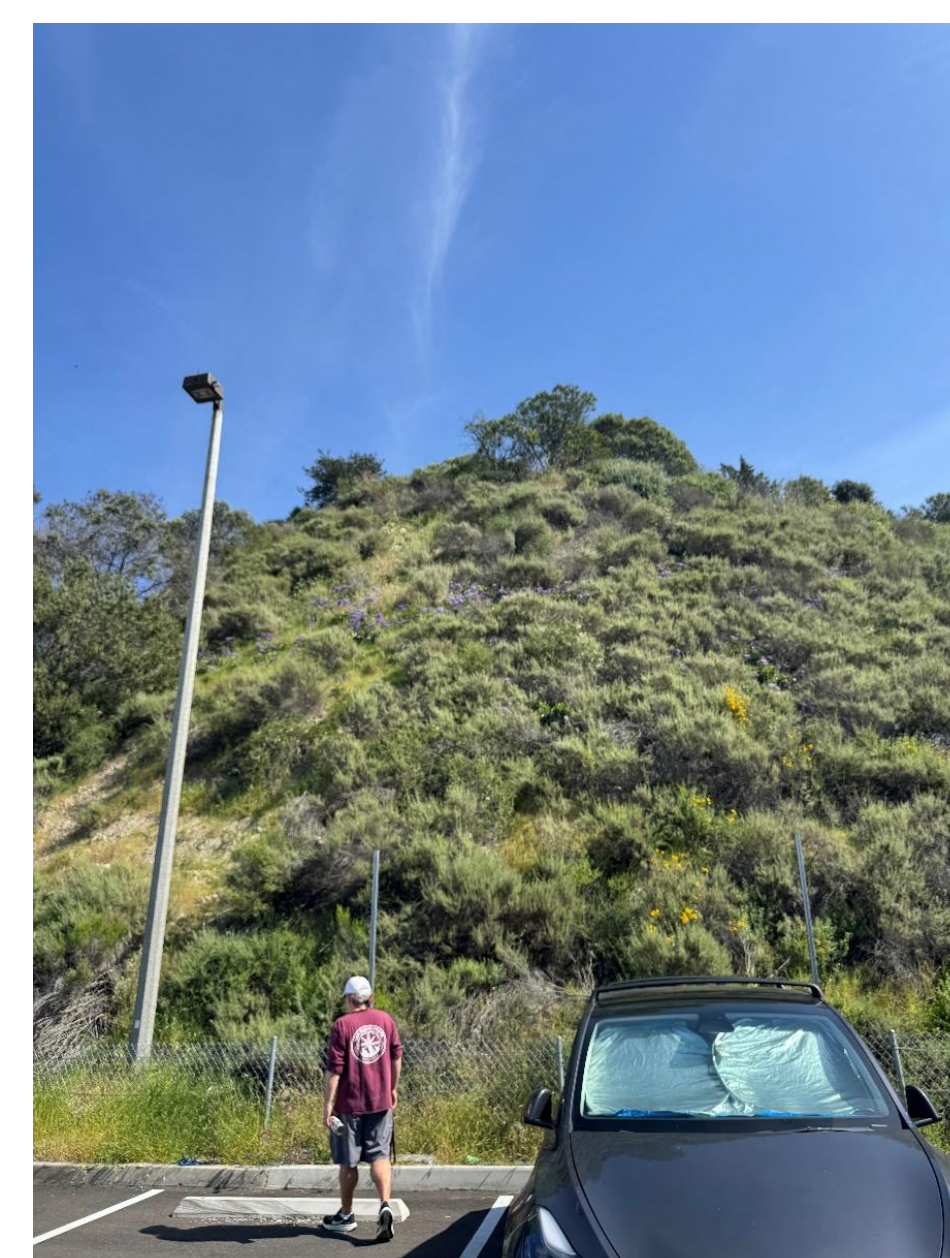
Image 9: ~65° angle of repose on hillslope north of parking structure 14.
